# SoCal Home Inspects, LLC

1234 Pleasant Ave., Beautiful, CA 91234  
Inspection prepared for: Sewer Scope  
Real Estate Agent: Bitu Tahmasebi - Berkshire Hathaway HS California Properties

Date of Inspection: 9/8/2022 Time: 12:30 PM  
Age of Home: 1951 (71 Years Old) Size: 1,019 Sq. Ft.  
Weather: Cloud, Warm, Dry  
Order ID: 537

# SEWER SCOPE/DRAIN CAMERA INSPECTION

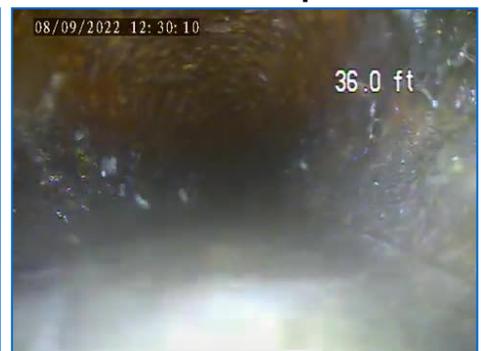
- Heavy rust/scale was visible in the cast iron portion of the main sewer line/pipe - the main sewer line/pipe should be cleaned of scale/hydro-jetted and re-inspected with a camera for damage and repaired or replaced as needed before the inspection objection deadline

Heavily rusted

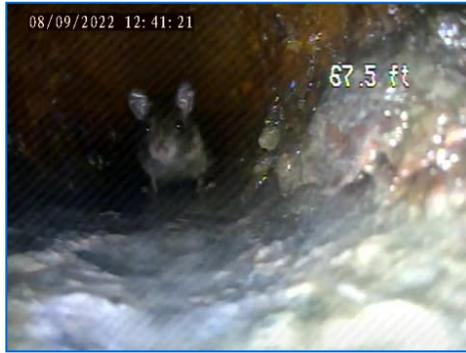
- The Inspector observed rats in the sewer during a sewer inspection - recommend contacting a qualified pest control contractor to discuss options and costs for ridding the structure of rodents and securing it from further rodent entry

**Sewer rat**
