# SoCal Home Inspects, LLC

1234 Pleasant Ave., Beautiful, CA 91234  
Inspection prepared for: Sewer Scope  
Real Estate Agent: Bitu Tahmasebi - Berkshire Hathaway HS California Properties

Date of Inspection: 9/8/2022 Time: 12:30 PM  
Age of Home: 1951 (71 Years Old) Size: 1,019 Sq. Ft.  
Weather: Cloud, Warm, Dry  
Order ID: 537

# SEWER SCOPE/DRAIN CAMERA INSPECTION

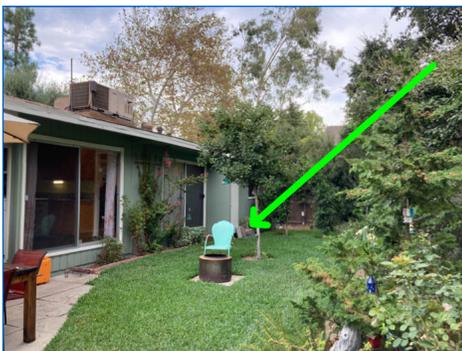
- A belly/low point that was holding water and debris was visible in the main sewer line/pipe at approximately **13 to 26 feet** from the access point - the main sewer line/pipe should be hydro-jetted and repaired as needed and re-inspected with a camera before the inspection objection deadline

- Heavy rust/scale was visible in the cast iron portion of the main sewer line/pipe - the main sewer line/pipe should be cleaned of scale/hydro-jetted and re-inspected with a camera for damage and repaired or replaced as needed before the inspection objection deadline

See next picture
